DETECTING CANAL SEEPAGE USING THE ELECTROMAGNETIC INDUCTION METHOD

Center for Irrigation Technology, California State University, Fresno, CA

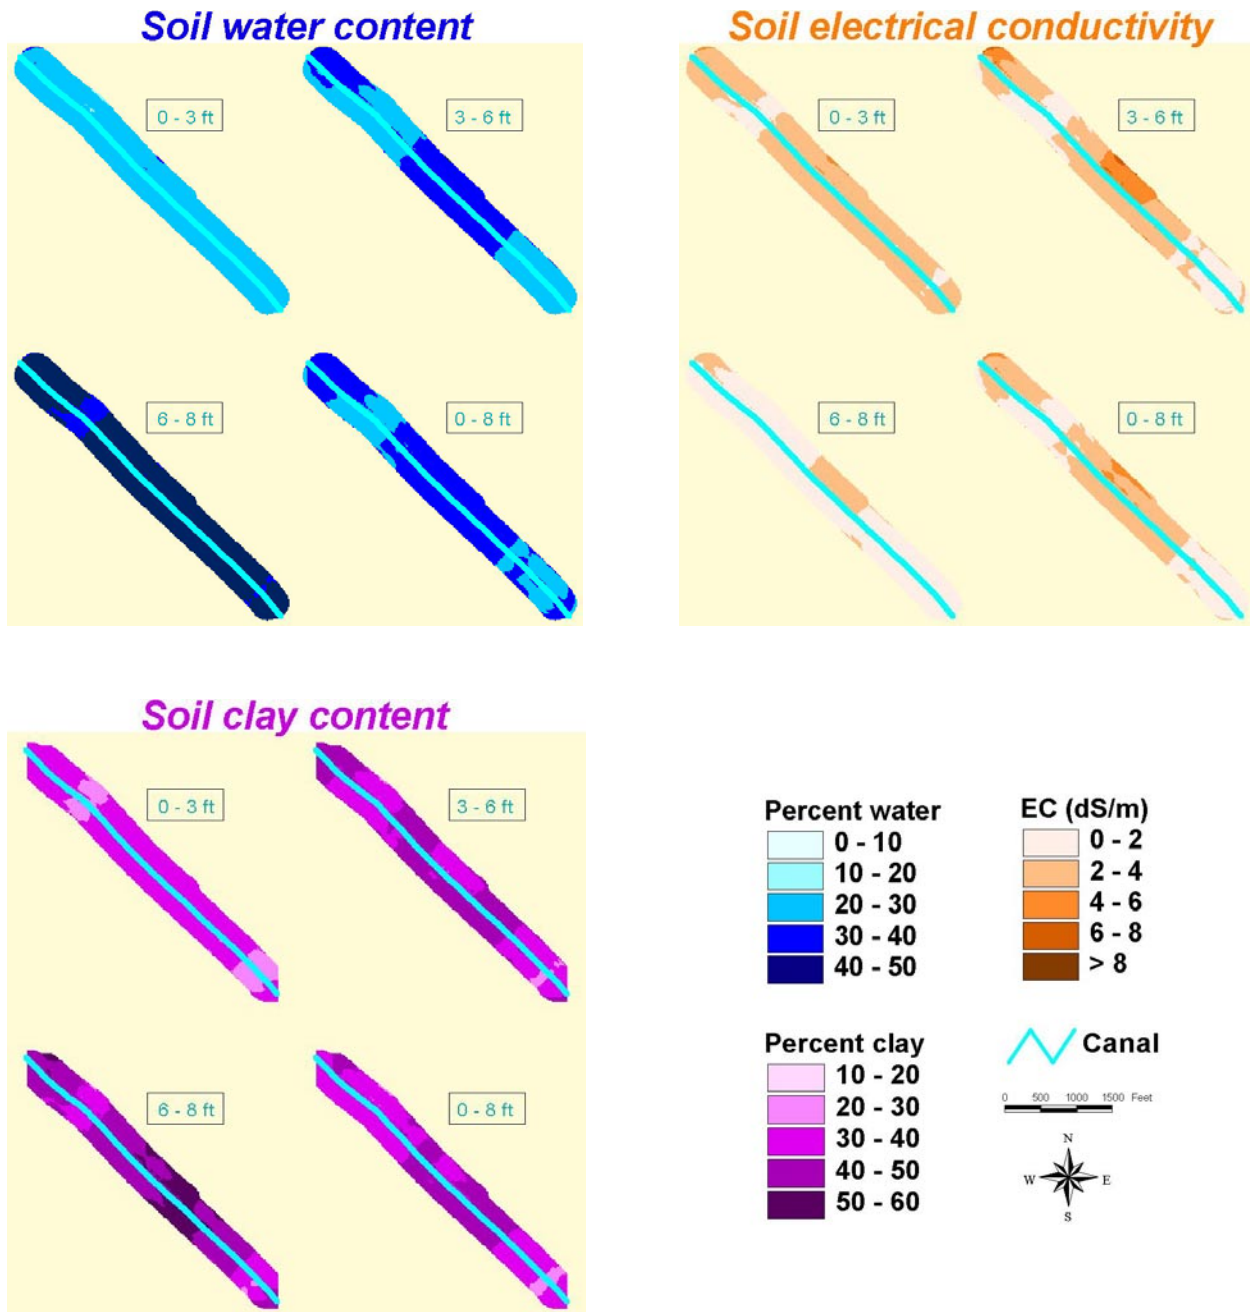
Contour maps showing the distribution of soil moisture, EC, and clay content along the canal at different profile depths in August 2001 are presented in Figure 2. Soil water content was lowest near the surface (0-3 ft) with values ranging from 20 to 30%. The maps also showed that water content increased with depth. The 6-8 ft profile had the highest moisture levels (up to 48 cm^3 cm^{-3}) due to the presence of water table at those depths. In the 3-6 ft soil profile, water content ranged from 20 to 40% with greater percentages found in the mid-section and north-east segment of the canal. Higher soil water content could be indicative of potential seepage. Water loss in those sections of the canal was also observed by the Water District.

In August, soil EC ranged from 0.5 to 9 dS/m throughout the profile. The lowest values (<4 dS/m) were observed at higher depths (6-8 ft). Soil EC was greater in the mid and north sections of the canal at the 3-6 ft depth, with highest values always found on the eastern side of the canal. This pattern was similar to that noted on the soil water content maps.

Results also indicated that percent clay content increased with soil depth and ranged from 11 to 53%. This is indicative of coarser-textured soil and lower water holding capacity at the surface. Throughout the soil profile, higher clay contents (40-53 %) were observed in the mid-section of the canal. However, lower clay percentages (20-30%) were found in the middle-eastern side of the canal at 3-6 ft depth. At that location, soil water content and EC were particularly high, which could suggest potential seepage.

Figure 2. Distribution of soil water content, electrical conductivity, and clay content along the irrigation canal at different depths in August 2001.

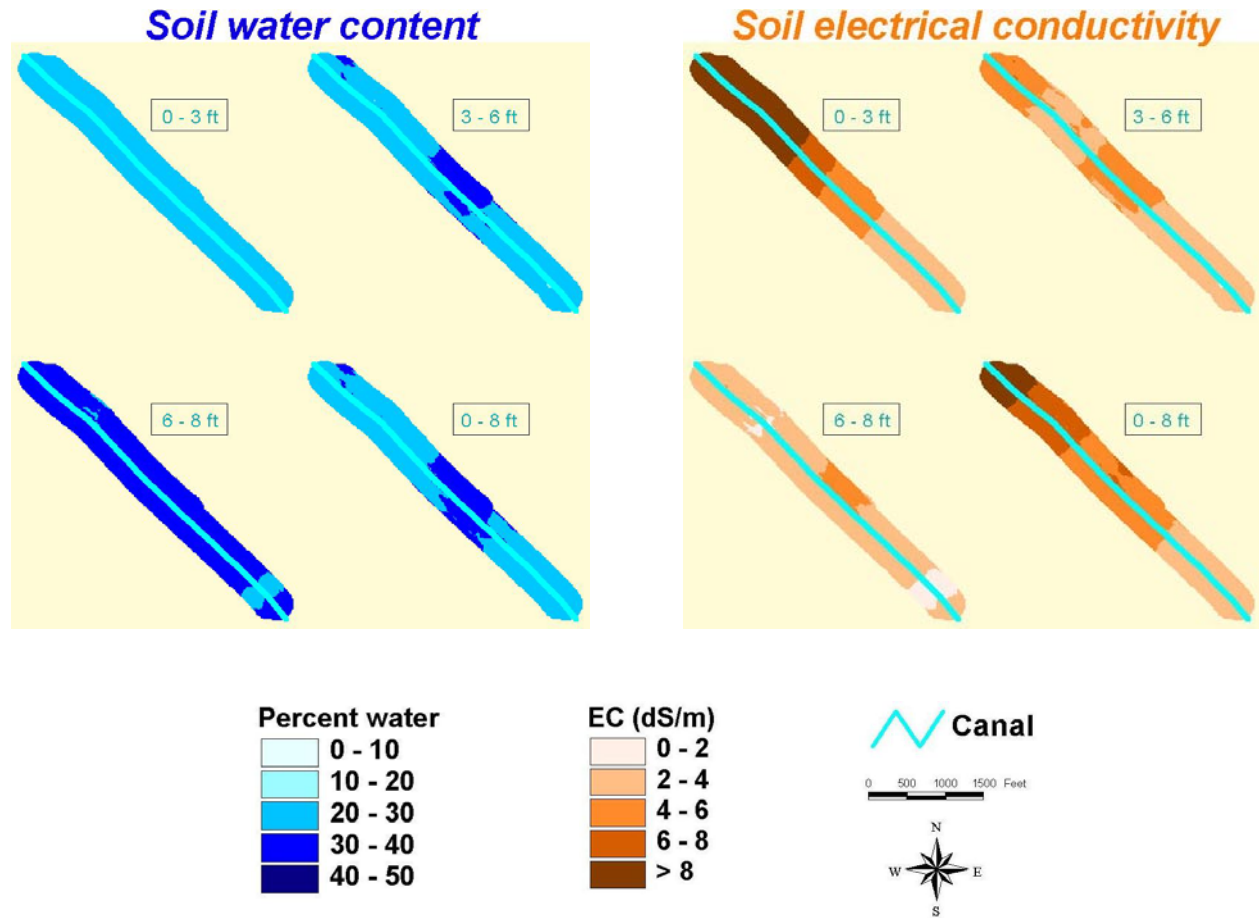
Changes in soil water content and EC observed in Octob8er 2001 after the canal had been closed are shown in Figure 3. The maps indicated that water contents were very uniform and low (20-30%) at the soil surface (0-3 ft). Moisture spatial distribution and percentages were comparable to those observed in August, suggesting that seepage is unlikely near the soil surface. In October, low soil water contents were also found at the 3-6 ft depth, except in the mid-eastern section of the canal where values up to 40% were noted. This indicated that water percentages

did not decrease in that section after the canal had been closed and could confirm the possibility of seepage at that location and depth. Water content decreased through the 6-9 ft profile in October, although it remained highest than the upper depths due to the presence of water table. Average soil EC increased after closing the canal.

Figure 3. Distribution of soil water content and electrical conductivity along the irrigation canal at different depths in October 2001.
